Replacing Old Profurl Bearings

Starship's main working headsail is a high cut genoa, with a padded luff, on an N42 Profurl furler. The staysail is on a smaller N31 Profurl. Both furlers were purchased new in 1988 from Profurl's Australian agent, and worked reliably throughout our circumnavigation. In 2003, after a period of disuse I discovered the furling drums and the halyard carriers on both units had become very difficult to rotate by hand. Evidently moisture had got past the seals and was rusting the bearings (and as it turned out, the seal shells).

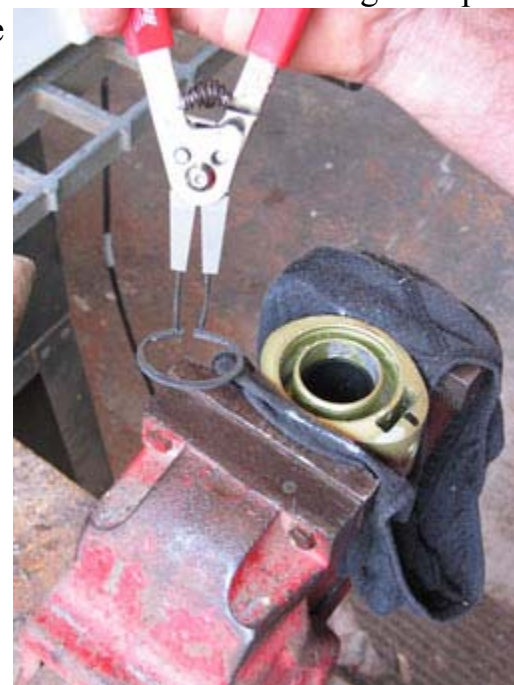
numerous circlips from the very confined and deep annular recess between the housing and spar carrier proved the only difficult part of the job. My reversible (can be used for internal and external circlips) Repco circlip pliers were not really up to the job, their tips being much smaller than the holes in the circlips, allowing the clips to twist and then slip off the tip. In several instances I eventually had to insert thin stainless shims to prevent the circlips slipping back into their grooves and then drag the circlips out spirally using a wire loop passed through one of the holes. Circlips are standard engineering components, so I could probably have bought replacements, but fortunately these proved malleable enough to be bent back to their correct shape and re-used.

After removal of circlips I used a hammer and various suitable short sections of aluminium tube to carefully drive the bearings out, and later to tap in the new components. They were not very tight fits, but during re-assembly the tubes should bear on whichever race (inner or outer) is being forced in or on at the time..

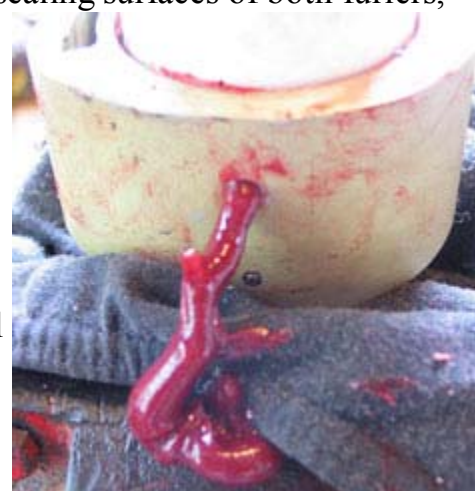
The photo below shows the components for the N31 halyard carrier, but although they look physically different the carriers and drums are very similar internally, each containing a single standard deep groove carbon steel ball bearing, grease lubricated, and protected either side with a standard nitrile rubber double lip oil seal with sprung skirts and steel shells. The nitrile cases were heavily degraded, but not apparently by sunlight because the lower seals were in a similar state. The encased steel shells were heavily rusted, which is hardly surprising after 15 years. Profurl claim their current seals have stainless steel inserted shells. The drum and carrier used the same size bearings and seals, and the seal dimensions and bearing # were stamped or moulded into each component.

The anodizing had indeed worn through on parts of the sealing surfaces of both furlers, but since the bearings had not actually collapsed the marks were smooth and shallow, and would probably seal satisfactorily for sometime yet, especially in conjunction with fresh grease. More significant were a couple of scratches caused in extracting the circlips, which I smoothed out as best I could with a very fine emery stone.
