Tayana Owners Group
Norm Demain
3644 Holmes View Drive
Langley, WA 98260
Newsletter #29
Winter 85/86

DOC ROCKS TEAK TREAT AND OTHER WORDS OF WISDOM FROM OUR
PHILIPPINE CORRESPONDENTS DON & BEV ROCK

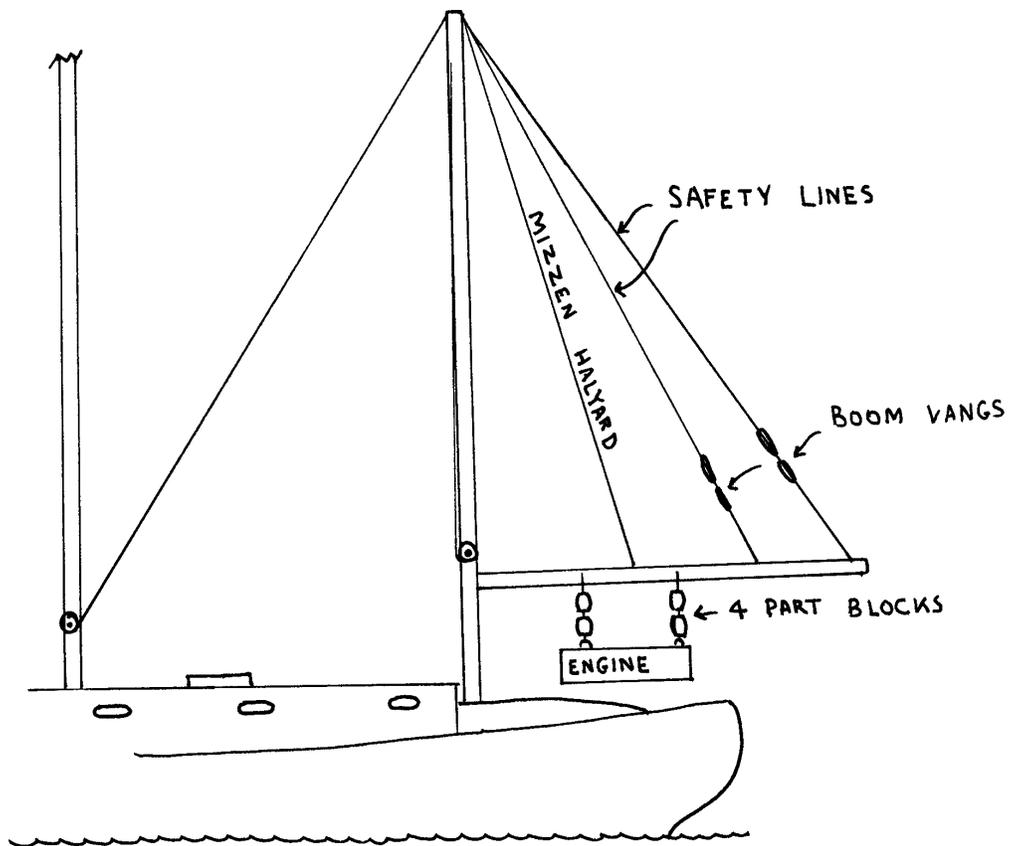
First all, the engine accessories and wiring harness were removed. The rear engine mounts were totally corroded. Standing on his head Al used a hack saw blade to cut them off. The prop shaft was disconnected. A 4x6 timber was laid across the companionway. Two, four part tackles were attached to the engine and 4x6. The engine and transmission were lifted, pulled forward, and set down on the cabin sole. The 250 lb. transmission was disconnected, leaving 500 lbs. of engine to be lifted. As the sketch shows, Al used his mizzen boom. The two four part tackles were attached to the boom. The mizzen halyard was attached to the boom midway between the two tackles. Two safety lines were run from the top of the mizzen mast to the end of the boom. Boom vang were attached at the ends of the safety lines. Another line was run from the top of the mizzen mast to the bottom of the main mast to help support the mizzen mast. The engine was raised using the tackles and the mizzen halyard. The boom vangs allowed the safety lines to be kept taut. A Mexican ponga (221 fiberglass skiff) was brought along side and the engine lowered into it. (A thin line with a float was attached to the engine just in case the engine wound up on the bottom of La Paz harbor - which is murky.) The four part tackles were used to raise the engine onto a dolly on the pier.

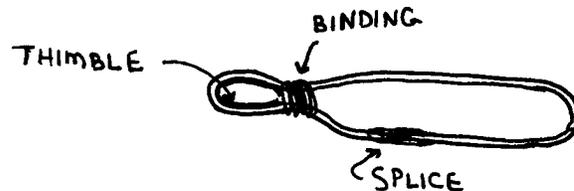
The two thimbles are joined together

This is laid over the chain just outboard of the roller after the anchor is set and brought through itself by the thimble. This thimble and the ones on the bridle are joined by the big shackle, and the shackle pin secured by a plastic wire tie. The small endless loop cinches tight on the chain when the windlass is slacked off. This takes all the load to the bits, and the slack chain to the windlass is the backup. (Don't forget to set the brake on the windlass after slacking off.)

We haven't used it yet, but we have a storm bridle made up. Two parts of 3/4" nylon have large eyes spliced inboard to cross over the twin posts. Their outboard ends are spliced around heavy thimbles. in a 7/8" shackle. The lengths of the two parts allow me to lay the outer shackle on the bow pulpit and lead the inboard eyes through the chocks and onto the bits. The key piece is an endless spliced loop about 21' long with a heavy thimble worked into one end.
