# TOG NEWS

A NEWSLETTER FOR TAYANA OWNERS

FALL 1988

## SHAFT ALIGNING

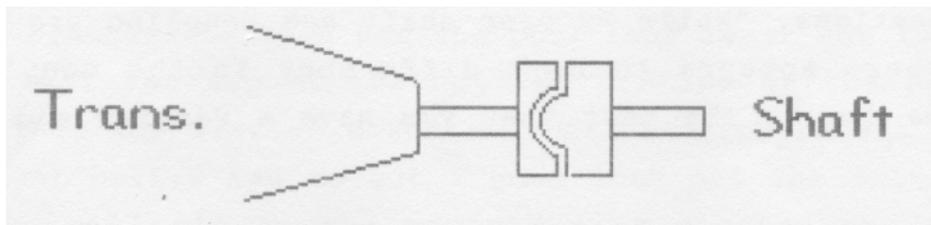
"On *PARALLAX* the two mating flanges of the coupling are separated by a 1" thick plastic vibration damper. With the damper removed, the two iron flanges line up as shown below:

Al's answer. "Regarding the straight edge, if your flanges are machined square then you can use a straight edge across the flanges. My flanges are not machined and appeared to be cast. You can move the engine by just loosening the jam nut and top nut and moving the lower nut with a wrench. Yes the rear engine mounts are a challenge. I can get to only the port rear one easily. What I do is loosen the bottom nut and the engine weight takes the tension off the top nuts. I can then just reach the top nuts with my hand and loosen them. I then move the lower nut up or down to adjust the port rear mount. By trial and error we line up the shaft flanges and then use the port rear lower nut to jam the mount against the top of the nut. My problem on the port rear mount is that the starter motor and bell housing sticks over the engine mount bolt. I had to cut a good inch off the bolt so that the engine will sit on the mount-I also slotted the mounting flange one inch and moved the mount back one inch to clear the bell housing.

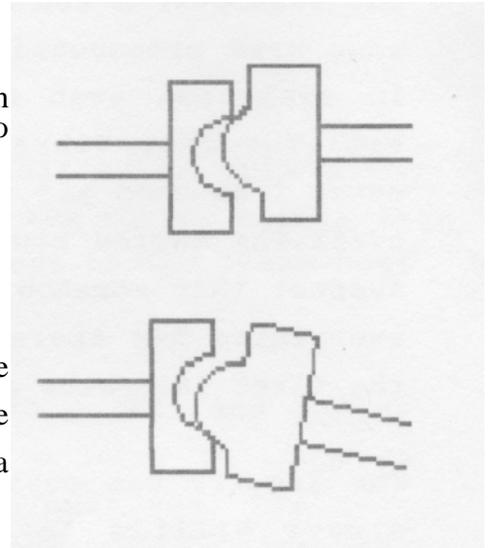
■ If the engine is too low as shown here, the flanges will not slide together, so it will have to be raised (more details later about how to reposition the engine).

■ The engine might also be out of line at an angle (either high or low or left and right) which again means that the engine has to be moved (figure at right).

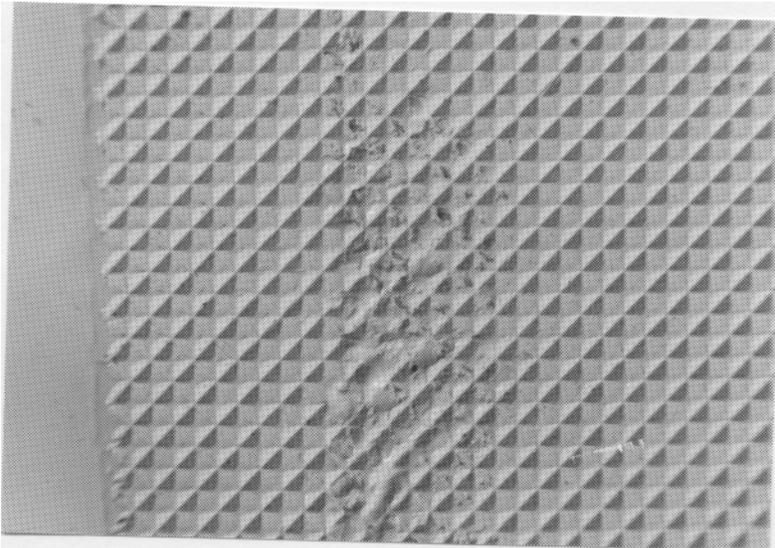
1. The non-skid surface on Don Cavanaugh's *Morning Dancer* is deteriorating (see pic) and he would like some advice from other owner's on how to fix the problem. He is also getting stress cracking at the base of the stanchions.

DETERIORATION OF NON SKID ON *MORNING DANCER*
